Manhole Inspection Summary

Manhole # S33UU1005MH

Location Address: **220 GOODALE RD**

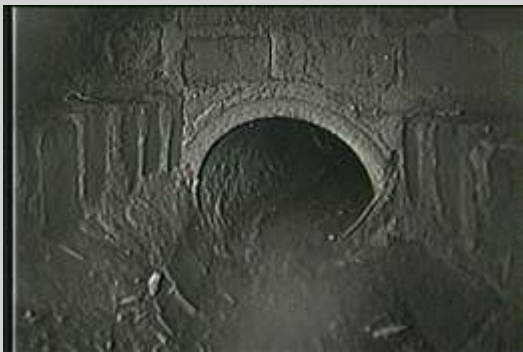
8 in. Circular Gravity Sewer Pipe Out @ 12 O'Clock

Rod and Bar (Angled)

Infiltration: **None** Pipe Seal Cond: **Unknown**
